Test Report

No.: NGBEC25001104401

Sample Name: SEMICONDUCTOR

Model No.: SMA

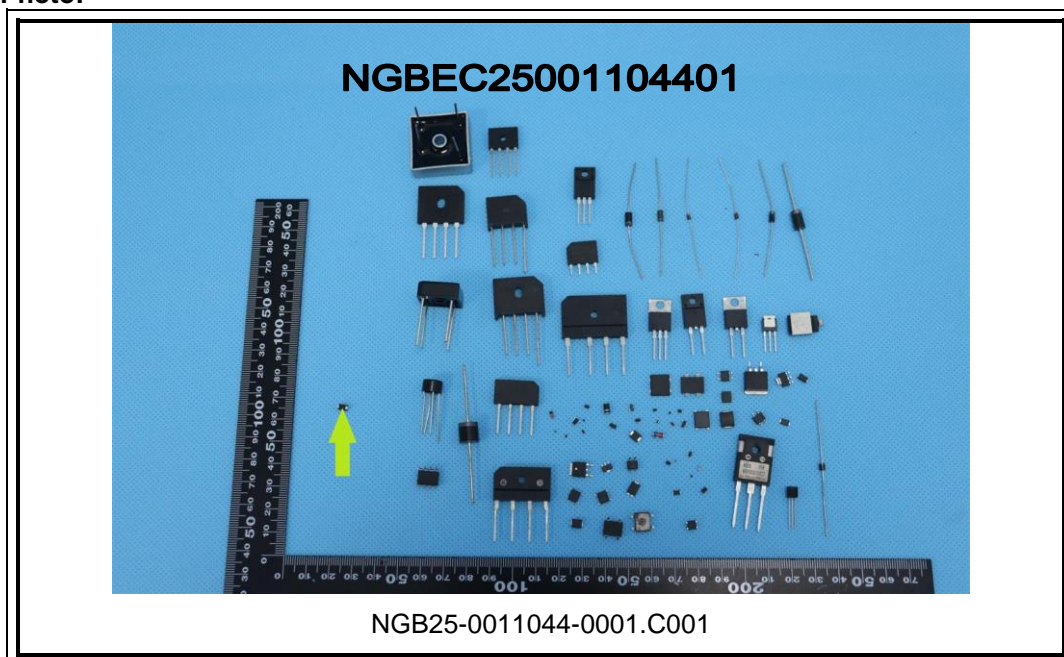
Sample Photo:

SN ID	Sample No.	SGS Sample ID	Description
SN1	A1	NGB25-0011044-0001.C001	Black body part
